LILY POND DAM IMPROVEMENTS ASSESSMENT

DEER ISLE, MAINE

PRELIMINARY DESIGN REPORT

December 20, 2022

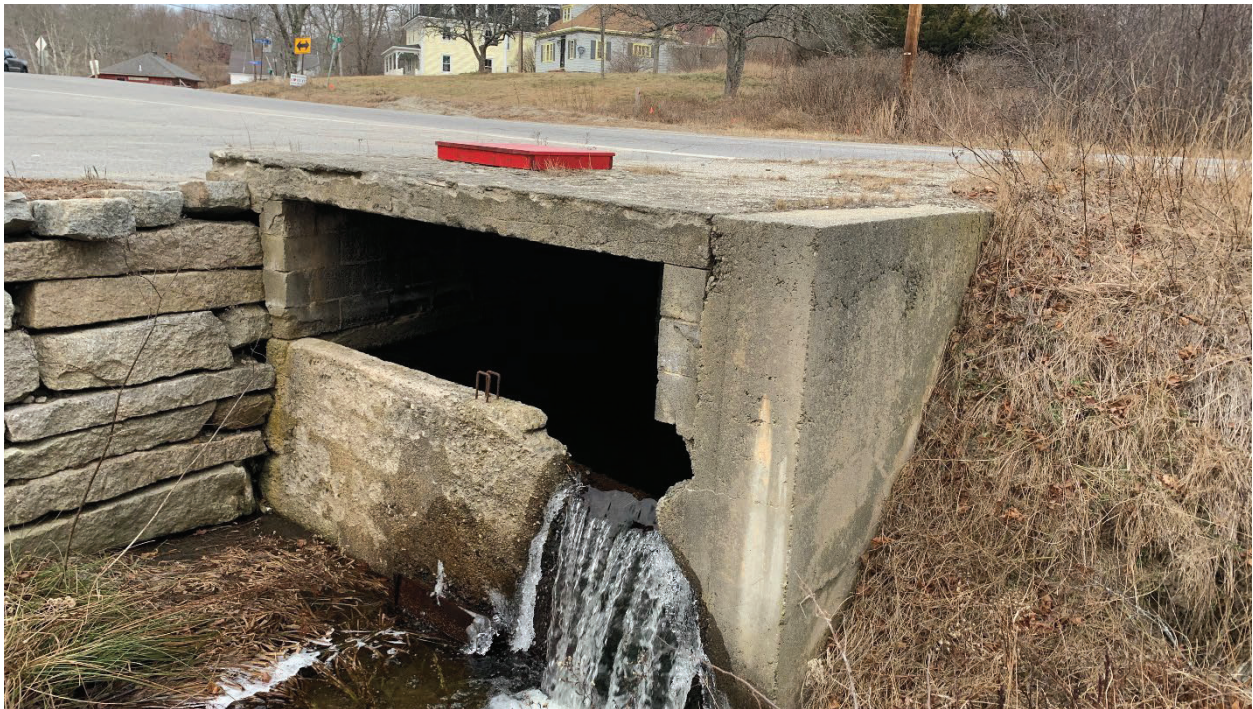
Fire Water Tank at Outlet of Culvert - Looking upstream with Route 15 in the Background

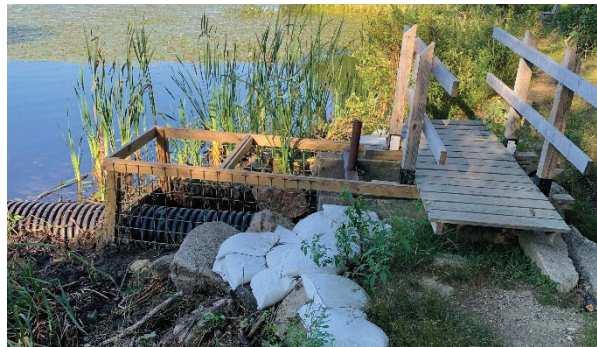
At the time of survey (January 6, 2021), the water level of Lily Pond was 87.3' (NAVD88). A beaver deceiver with an 18" diameter corrugated HDPE pipe was installed upstream of the concrete outlet structure. The outlet structure itself consists of an approximate two foot (2') wide concrete spillway fitted with a metal gate. At the time of the survey, the top of the gate was approximately 87.1' (NAVD88). The gate is also fitted with a threaded rod that allows the gate to be slightly elevated to allow for limited discharge under the gate panel. Based upon conversations with the Island Heritage Trust staff, this gate elevation is generally maintained and fixed throughout the year.

Photo 4.1: Beaver Deceiver at the Outlet of Lily Pond (8/8/2020)

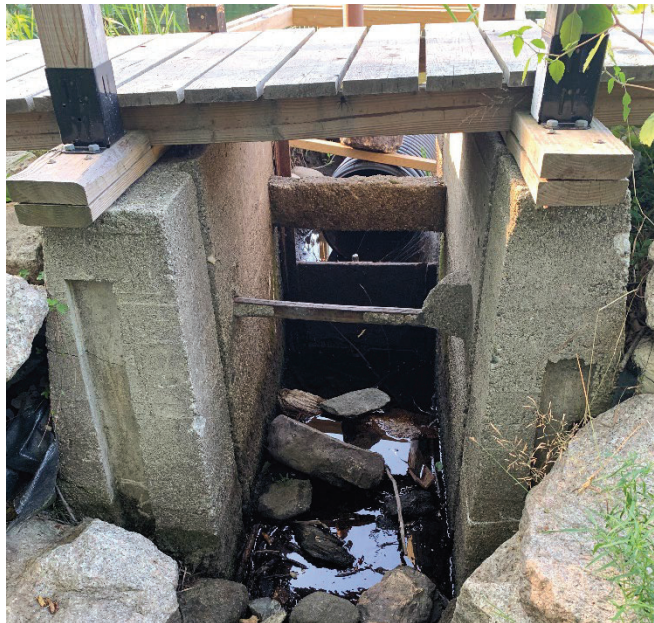
Photo 4.2: Two Foot (2’) Wide Concrete Spillway Structure with Metal Gate (8/8/2020)

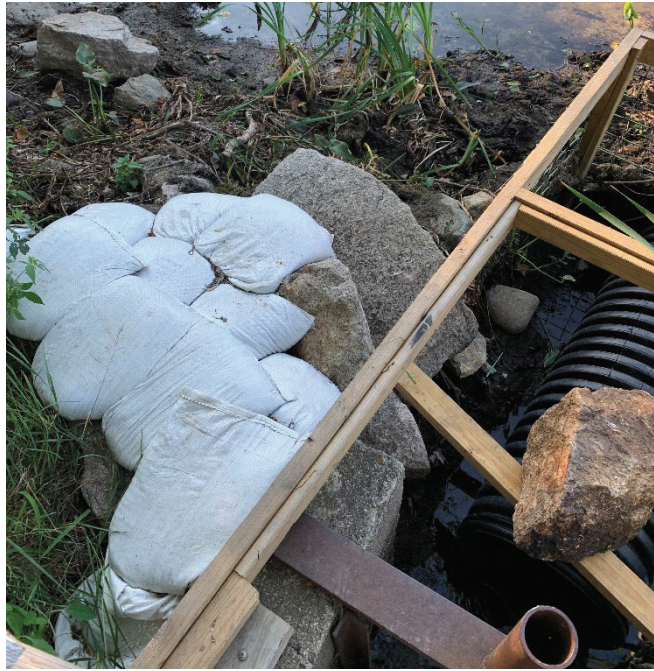
The Lily Pond dam shows clear signs of overtopping. The lowest point of the dam crest is located adjacent to the dam spillway. This area has visible evidence of erosion occurring over time and is currently being reinforced with sand bags. Reports from Island Heritage Trust staff indicates that this location of the dam has required repair with gravel fill several times in recent history. These anecdotal accounts and visual evidence are in alignment with the modeling results.

Photo 4.3: Area of Sandbag Reinforcement of Dam Embankment Erosion

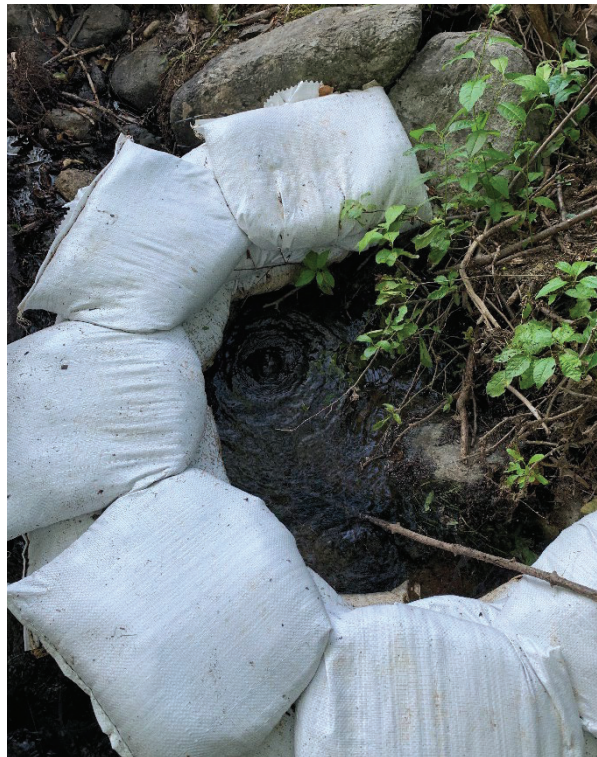
- A portion of this embankment is supported by dry laid stonework. Some erosion of the embankment (likely due to overtopping) is occurring and causing loss of soil cover and stonework.
- General erosion is occurring on the upstream embankment of the dam at the normal waterline of Lily Pond, due to wave action and hydraulic effects.
- Seepage is evident along the downstream toe of the embankment, as well as some limited pools of standing water. This seepage has been evident since at least 2013.
- A significant “boil” of water is evident adjacent to the spillway along the downstream toe of the embankment. Sandbags have been placed around the boil to limit the overall hydraulic pressure. The boil does not appear to be an imminent threat, however this could change quickly during a large storm event that may increase hydraulic pressure and trigger a piping erosion failure.

Photo 5.2: Significant hydraulic boil located along the dam toe adjacent to the Spillway

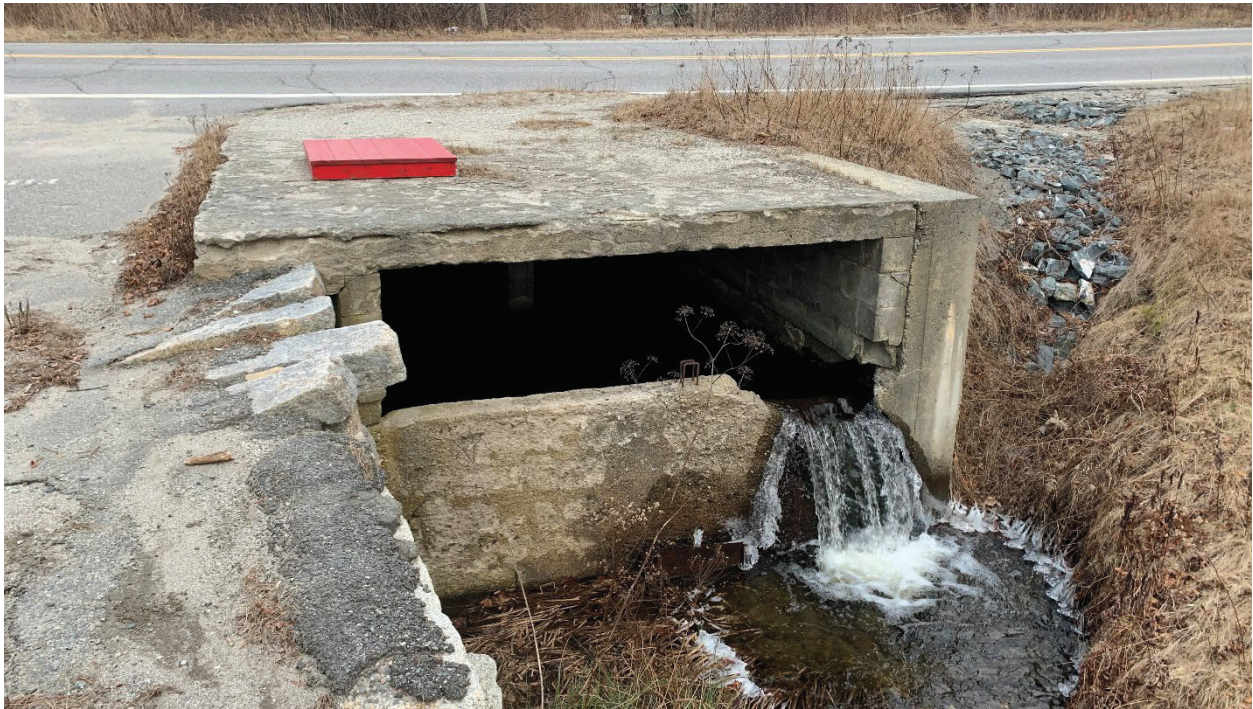
Fire Water Tank at Outlet of Culvert - Looking upstream with Route 15 in the Background

Route 15 it ultimately discharges into an aging concrete tank on the downstream side of the culvert. This concrete tank is used by the fire department to draw water from the stream for fire fighting purposes. As shown in the photo on the prior page, the tank structure is deteriorating and it represents a barrier to fish passage.

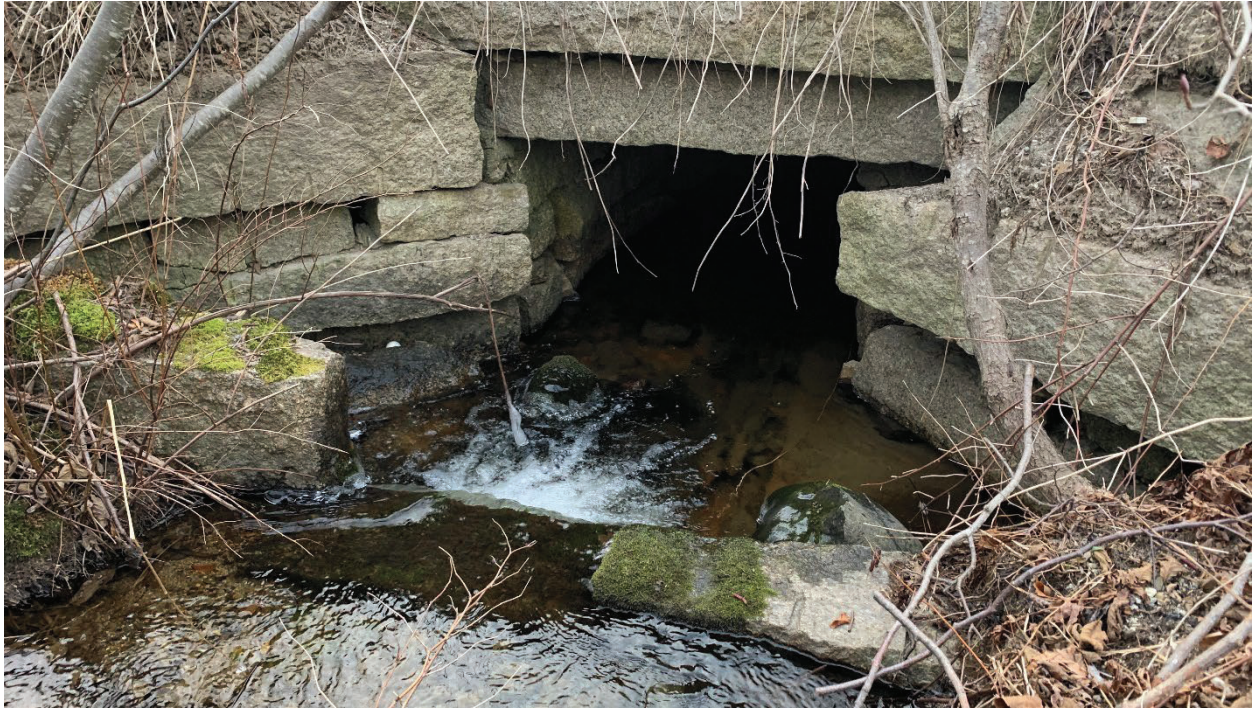
Route 15 Culvert Inlet - Looking Downstream

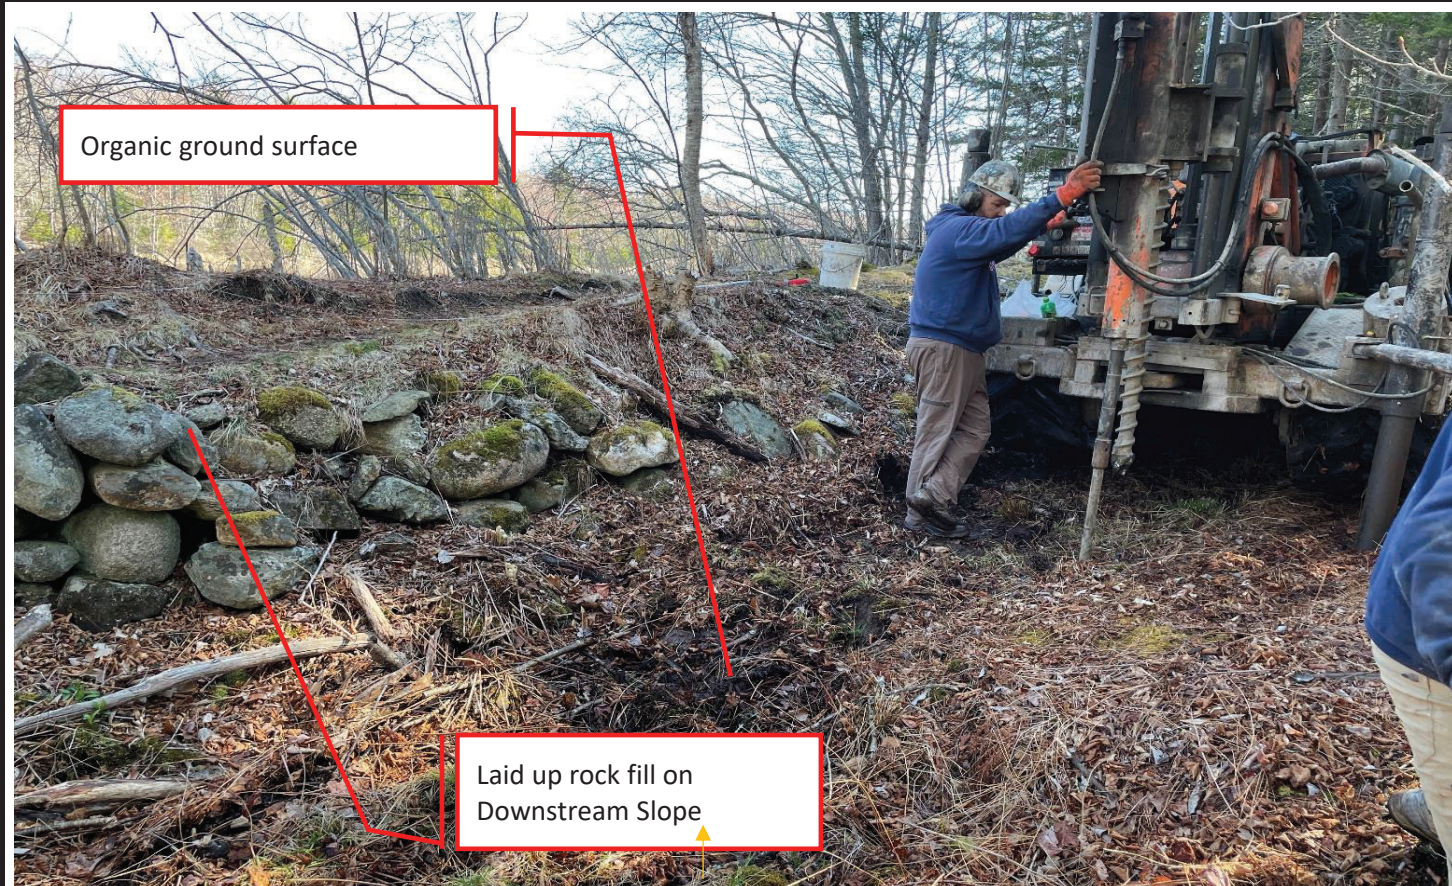
Organic ground surface

Laid up rock fill on Downstream Slope

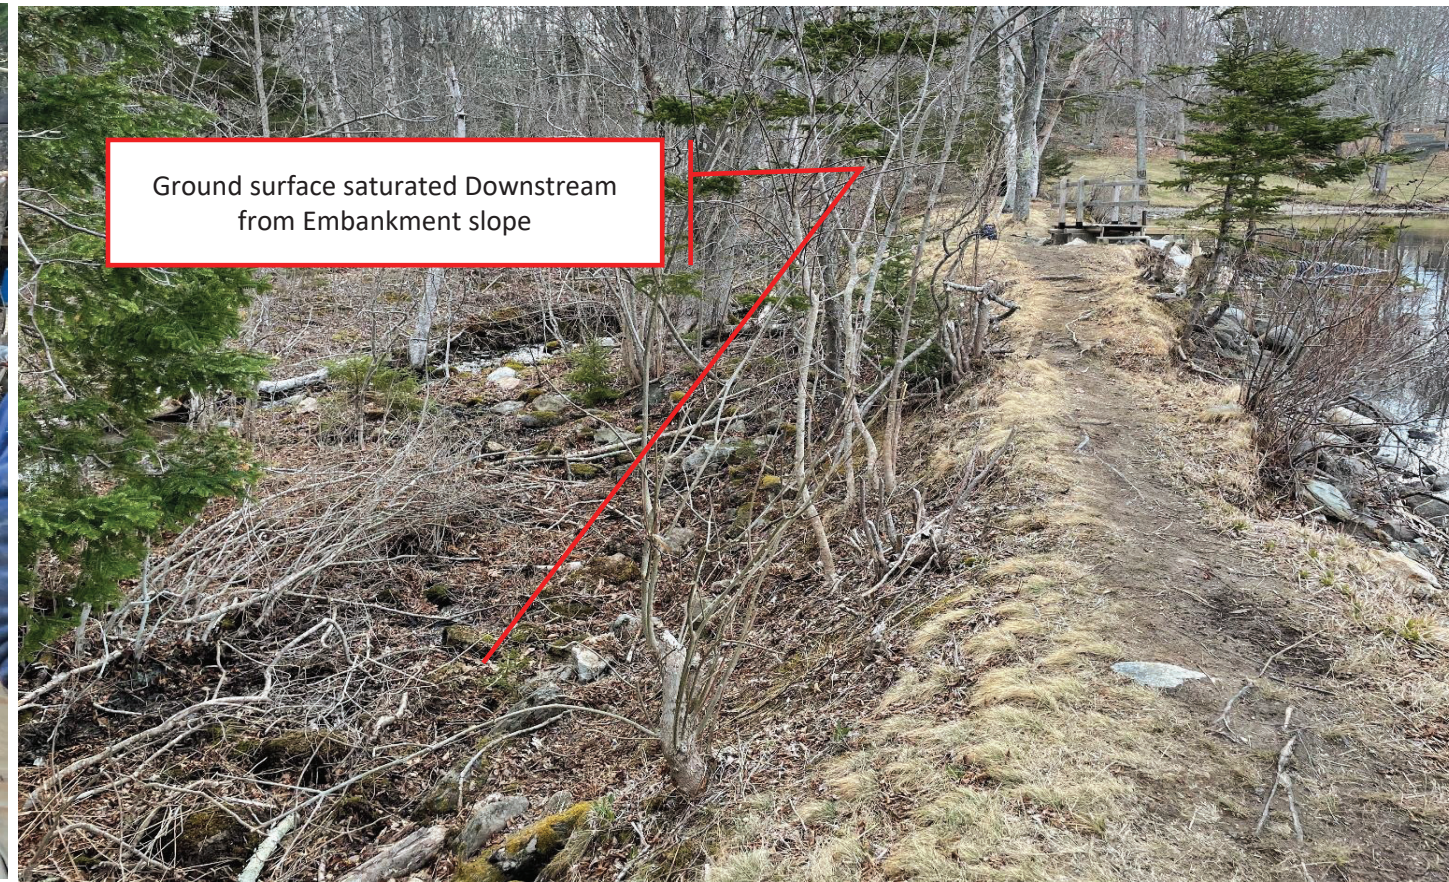
Ground surface saturated Downstream from Embankment slope

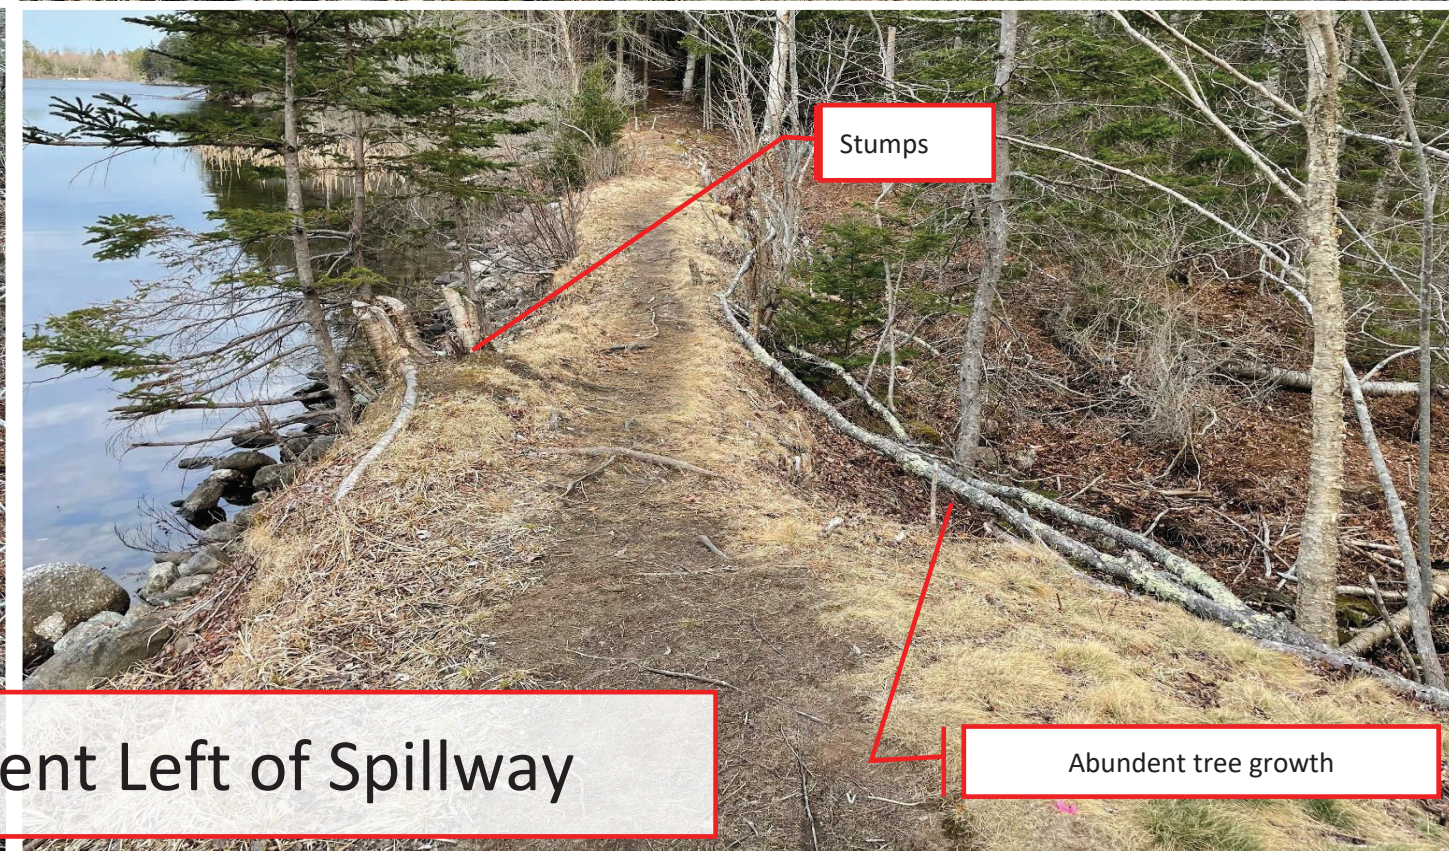
Stumps

Abundent tree growth

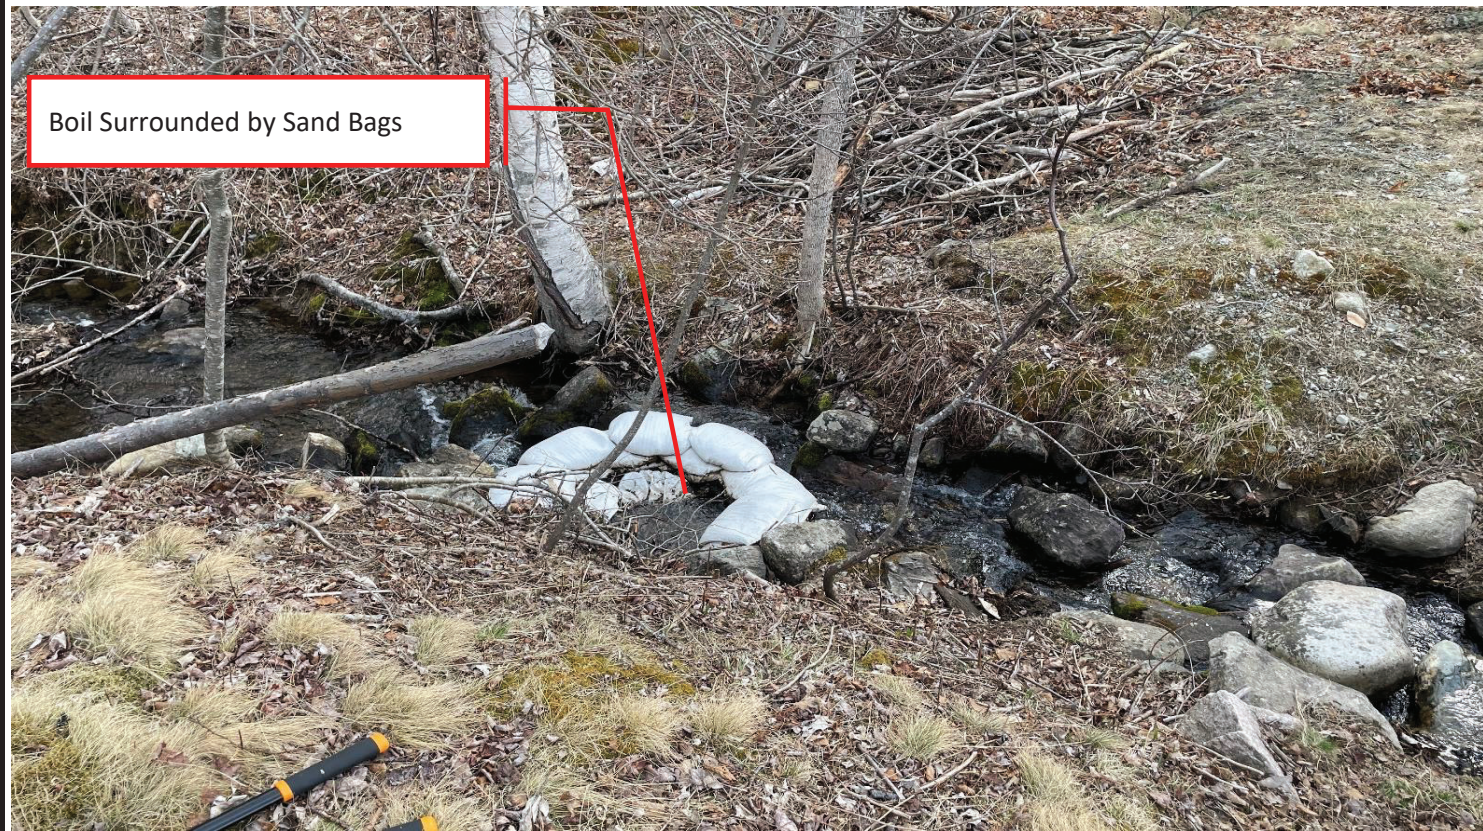
Boil Surrounded by Sand Bags

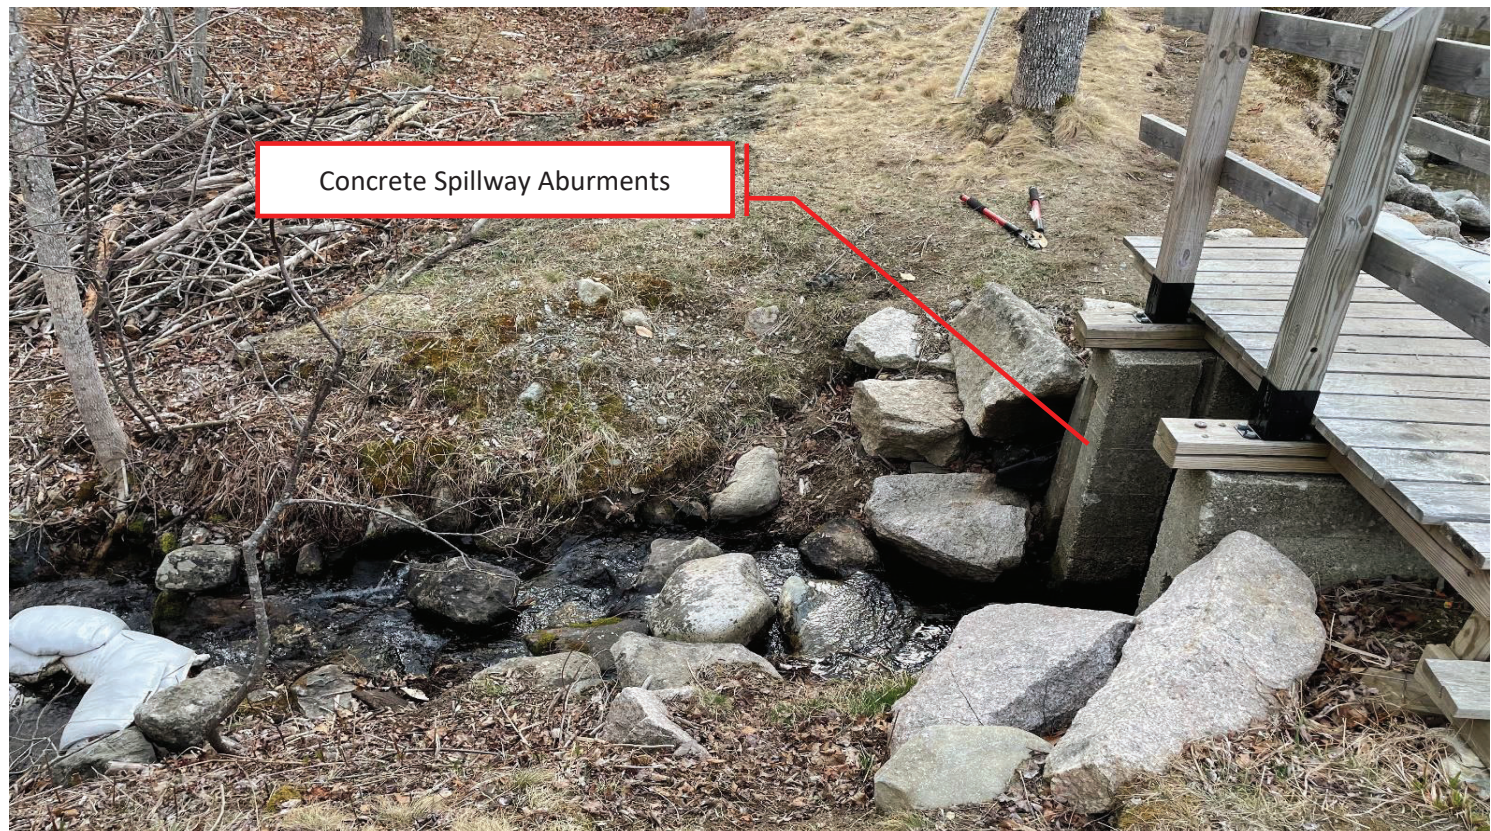
Concrete Spillway Abutments

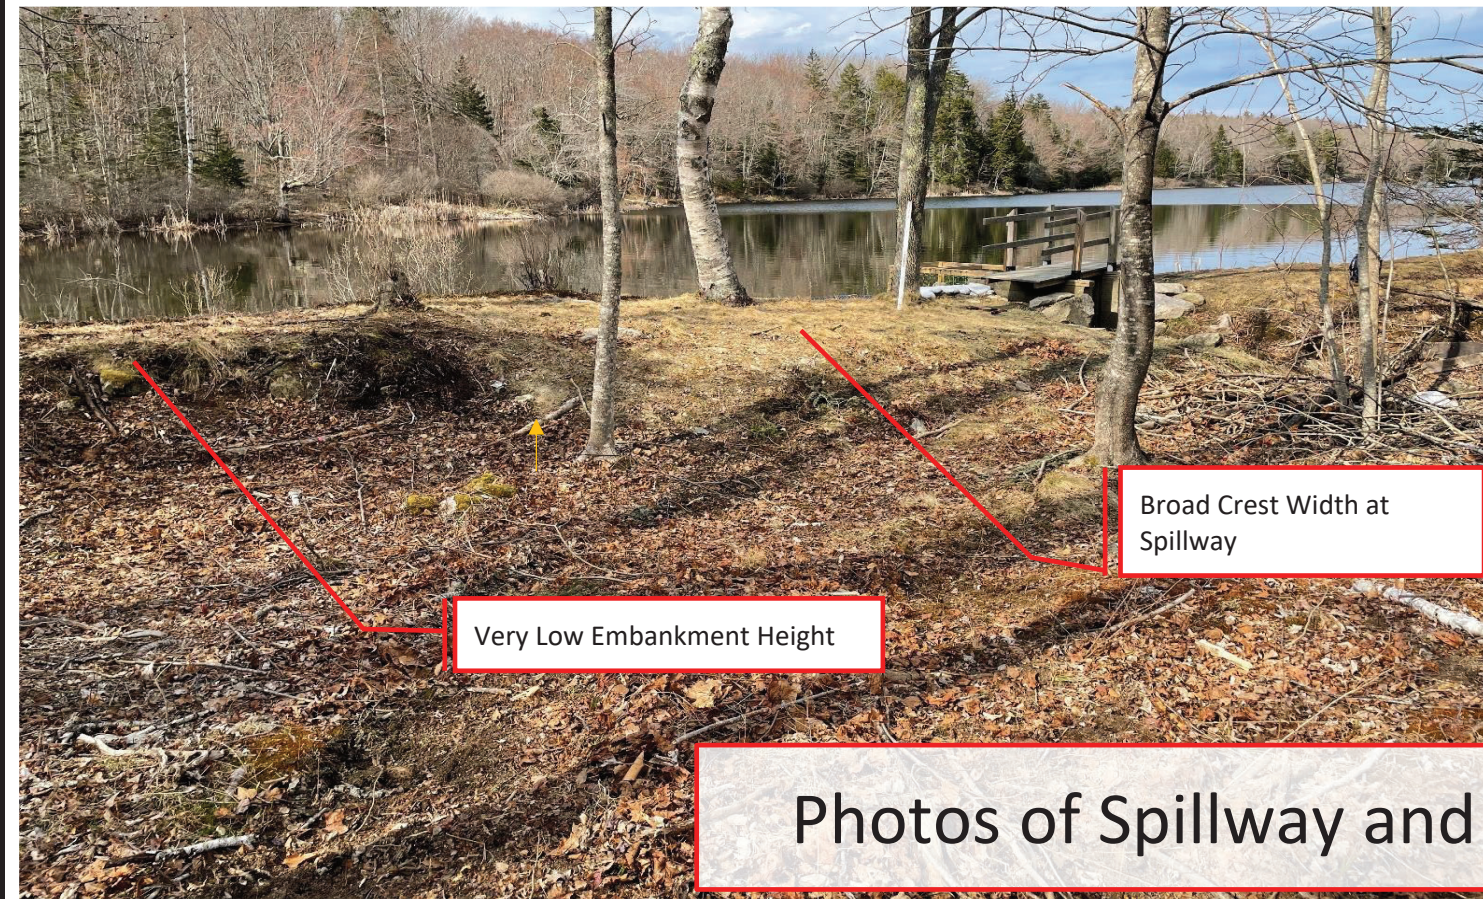
Very Low Embankment Height

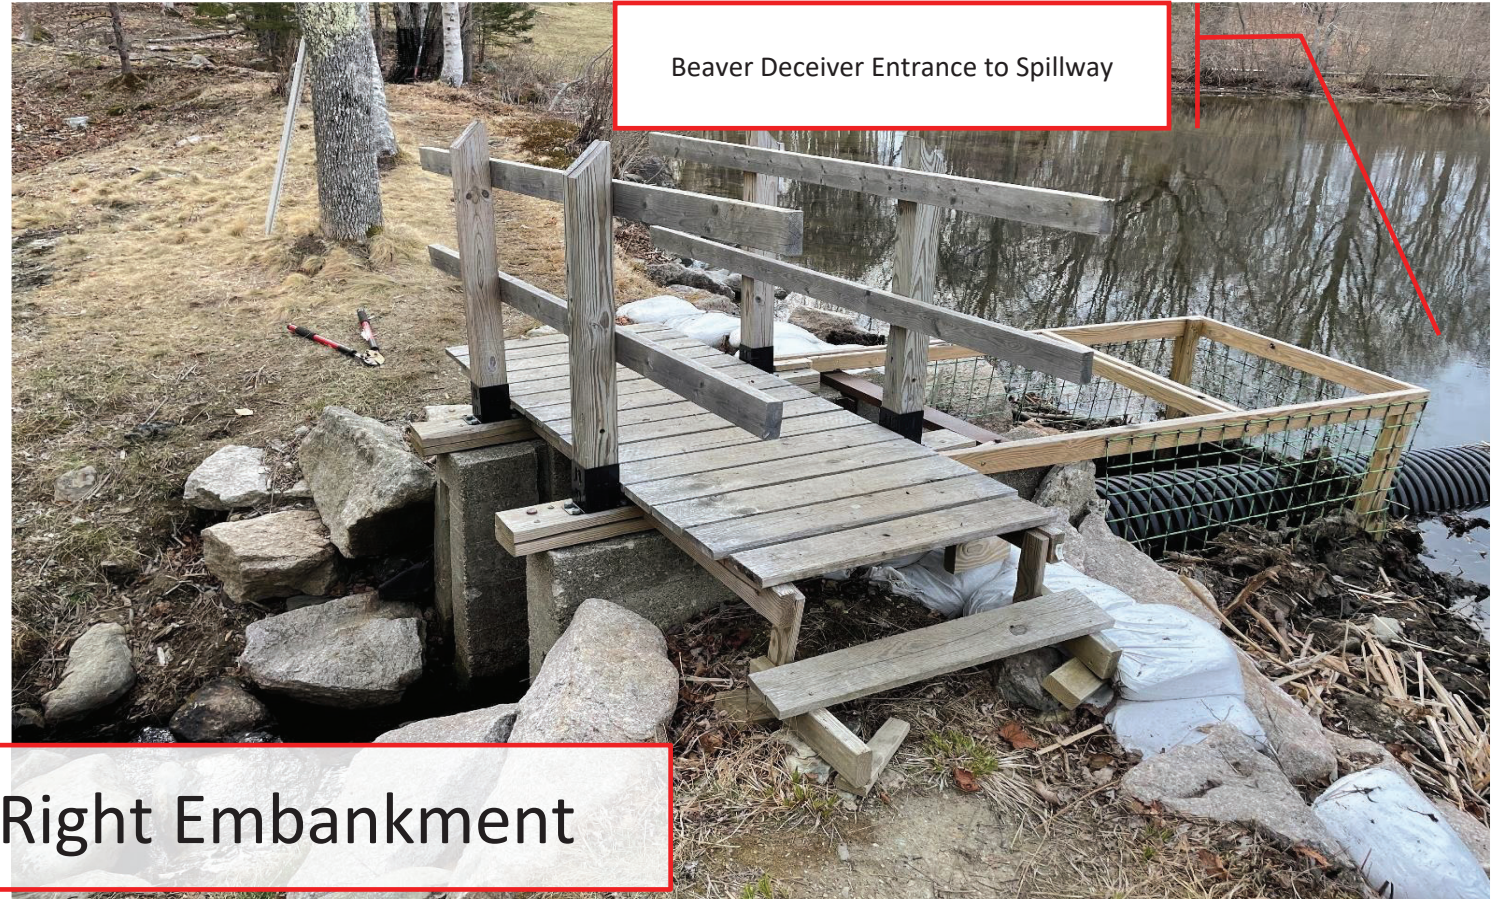
Beaver Deceiver Entrance to Spillway

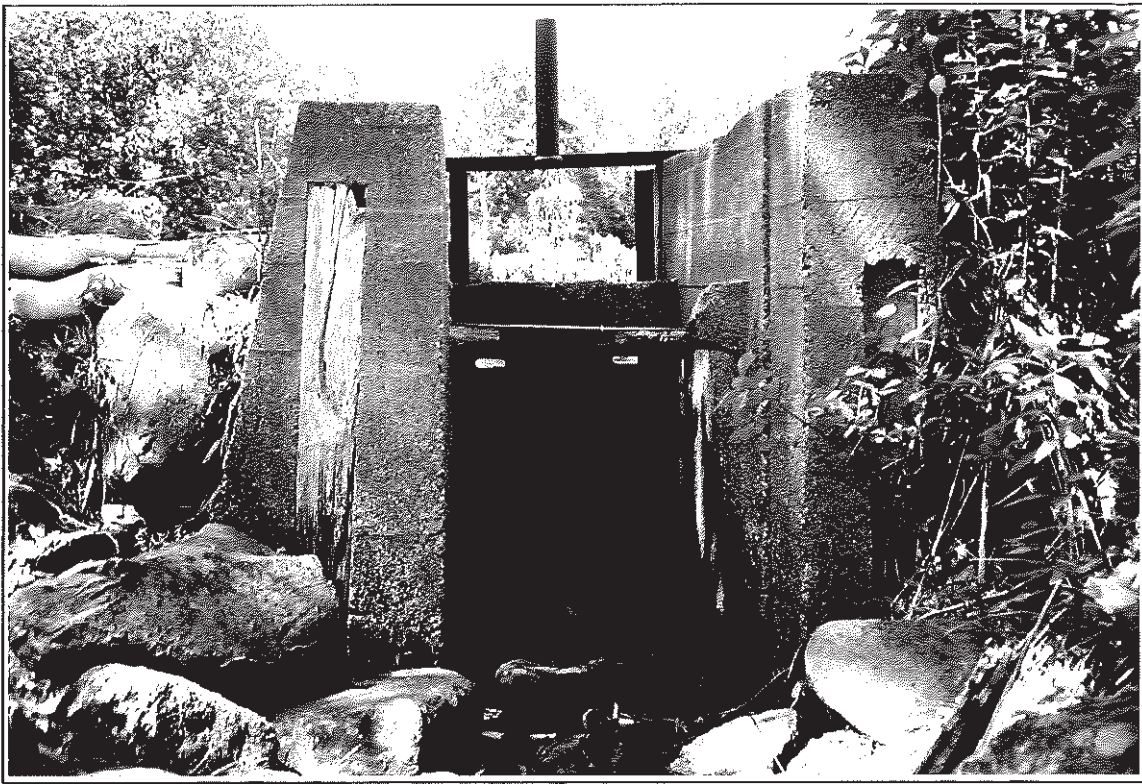
Photo B-1 Lily Pond Dam.
Downstream View of Sluiceway Structure.

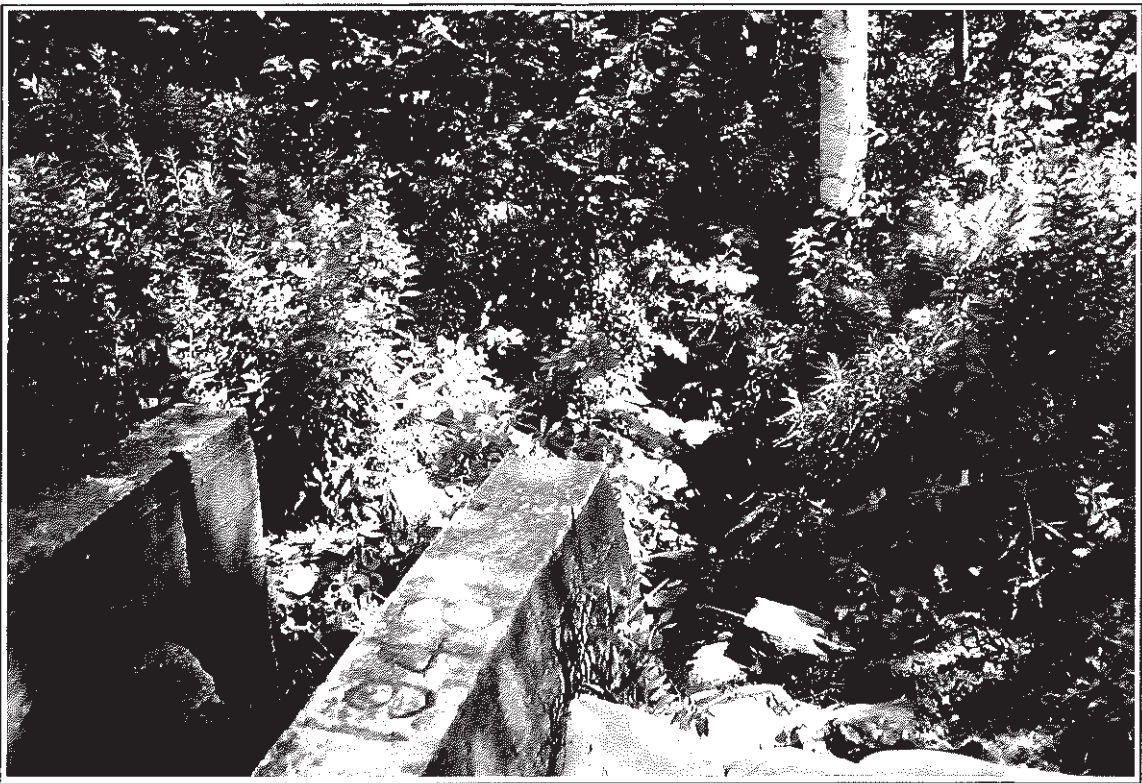
Photo B-2 Lily Pond Dam.
Sluiceway and Downstream Channel.

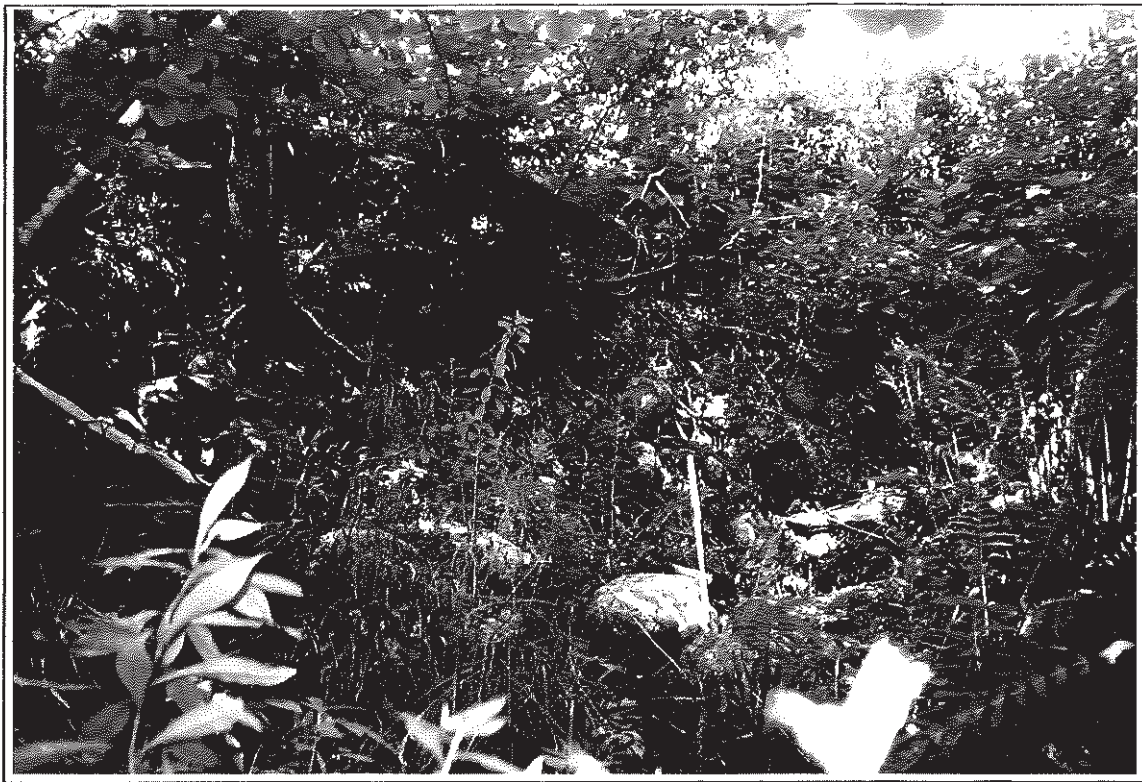
Photo B-3 Lily Pond Dam.
East Earthen Dike. Note Erosion on Downstream Slope and Seepage at
Toe of Dike.

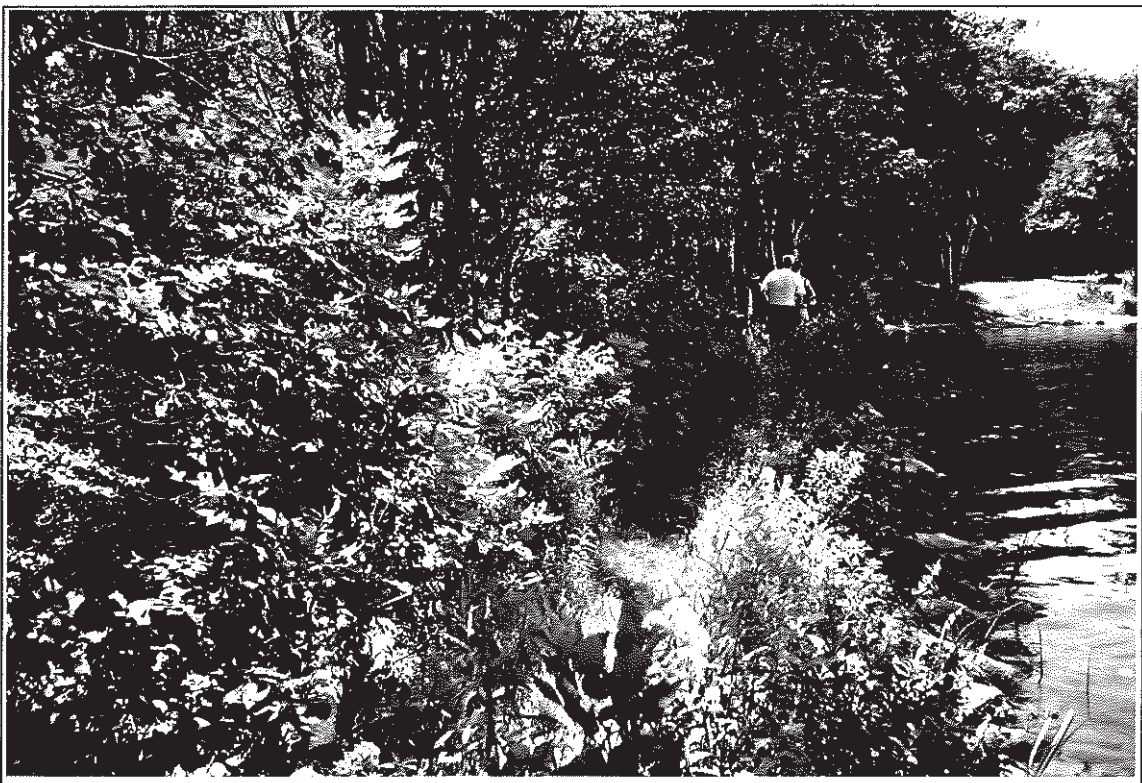
Photo B-4 Lily Pond Dam.
Top and Upstream Slope of West Earthen Dike.
