# MAINE OFFICE OF DAM SAFETY

SUBJECT: Dam Inspection Report for MEMA #106 - Lily Pond Dam

# MEMORANDUMTo:Steve Mallory, Maine Emergency Management Agency (MEMA)From:Nick M. Ciomei, P.E., Kleinschmidt Associates (Kleinschmidt)Cc:Tara Ayotte, MEMA; Anna Poppelreiter, E.I.T., MEMA; Nic Mills, E.I.T.,<br/>KleinschmidtDate:September 10, 2024Document No. 1534002\_07Re:State of Maine Dam Safety Inspection – Lily Pond Dam

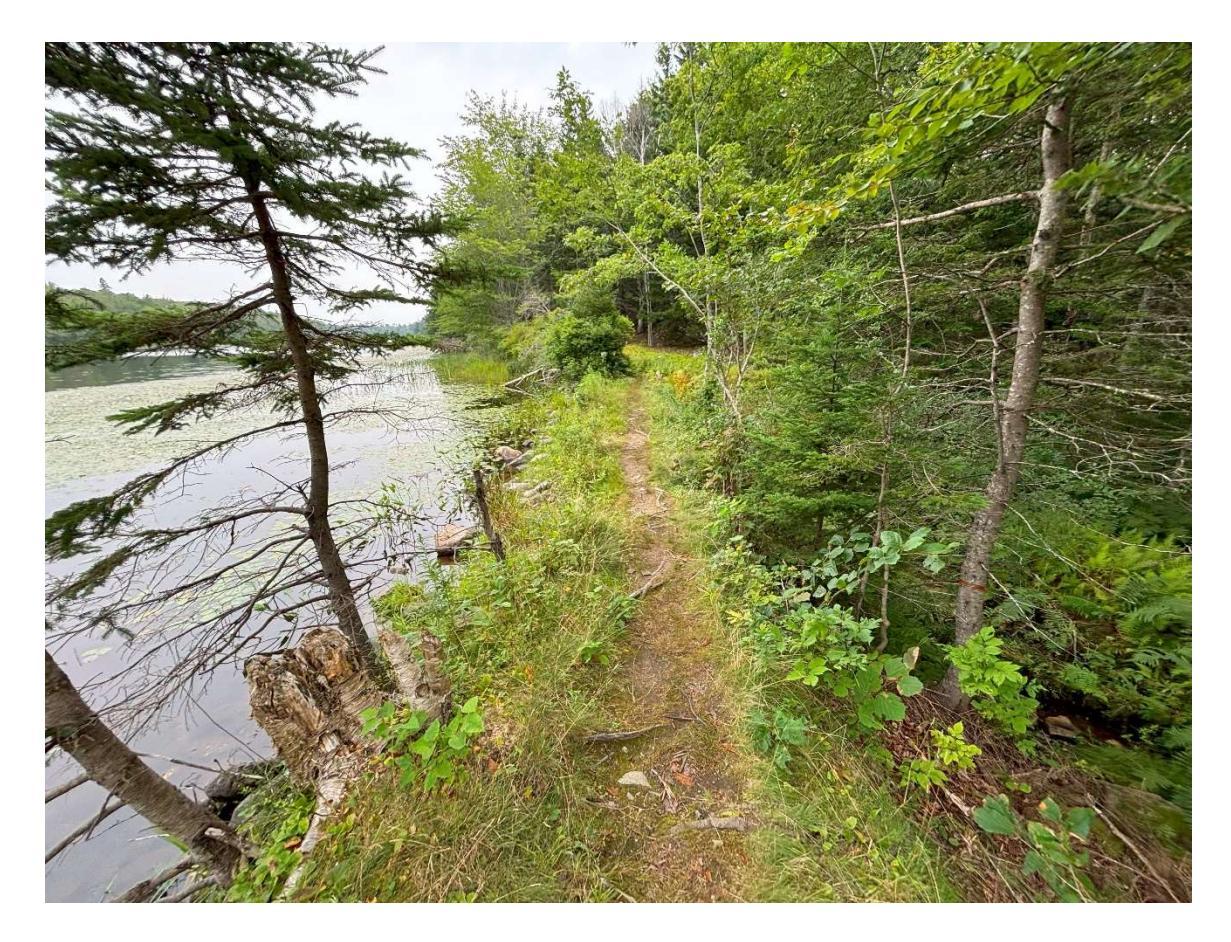
- Tree growth was noted on top of/near the left embankment along with some dead stumps which have not properly been removed which could eventually pose a risk for seepage through the dam (Photo 1, Attachment B).
- The crest of the embankment is consistently uneven, leading to concentrated areas of overtopping at elevations lower than originally intended/designed. Uneven embankment crests can result in accelerated failure events at lower flows (Photo 2, Attachment B).
- There was a significant amount of standing water noted on the downstream side of the left embankment. Its source is unknown; however, it looks as if it could potentially be due to seepage (Photo 3, Attachment B).

Photo 1: Tree growth and dead stumps along the upstream and downstream sides of the left embankment.

- Remove and properly backfill any trees and stumps that are located along the embankments.
- Regrade the dam crest, specifically the low spots, to prevent premature and concentrated overtopping.

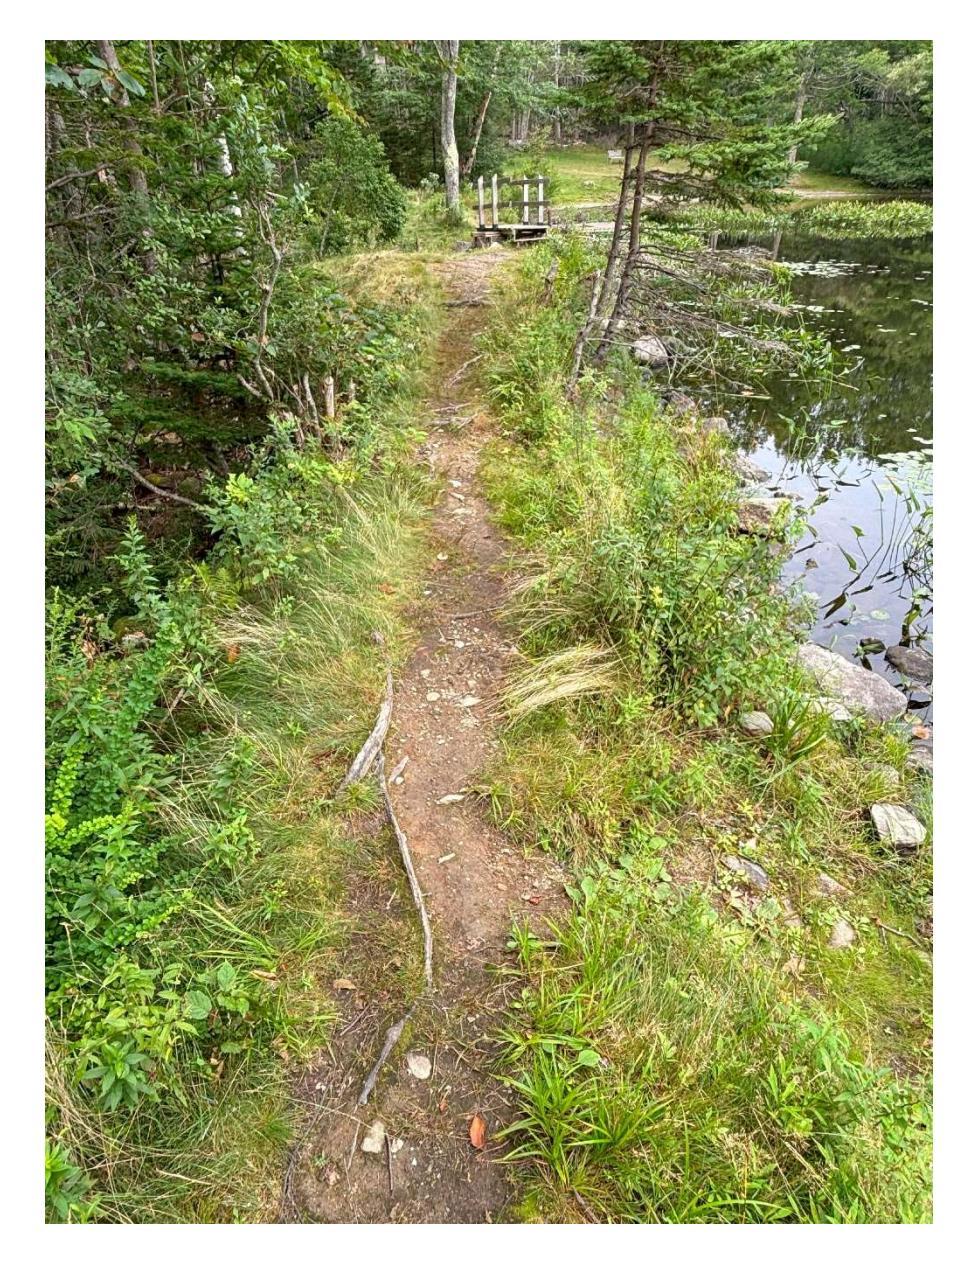
Photo 2: Low spot along the left embankment could provide a new overtopping location.

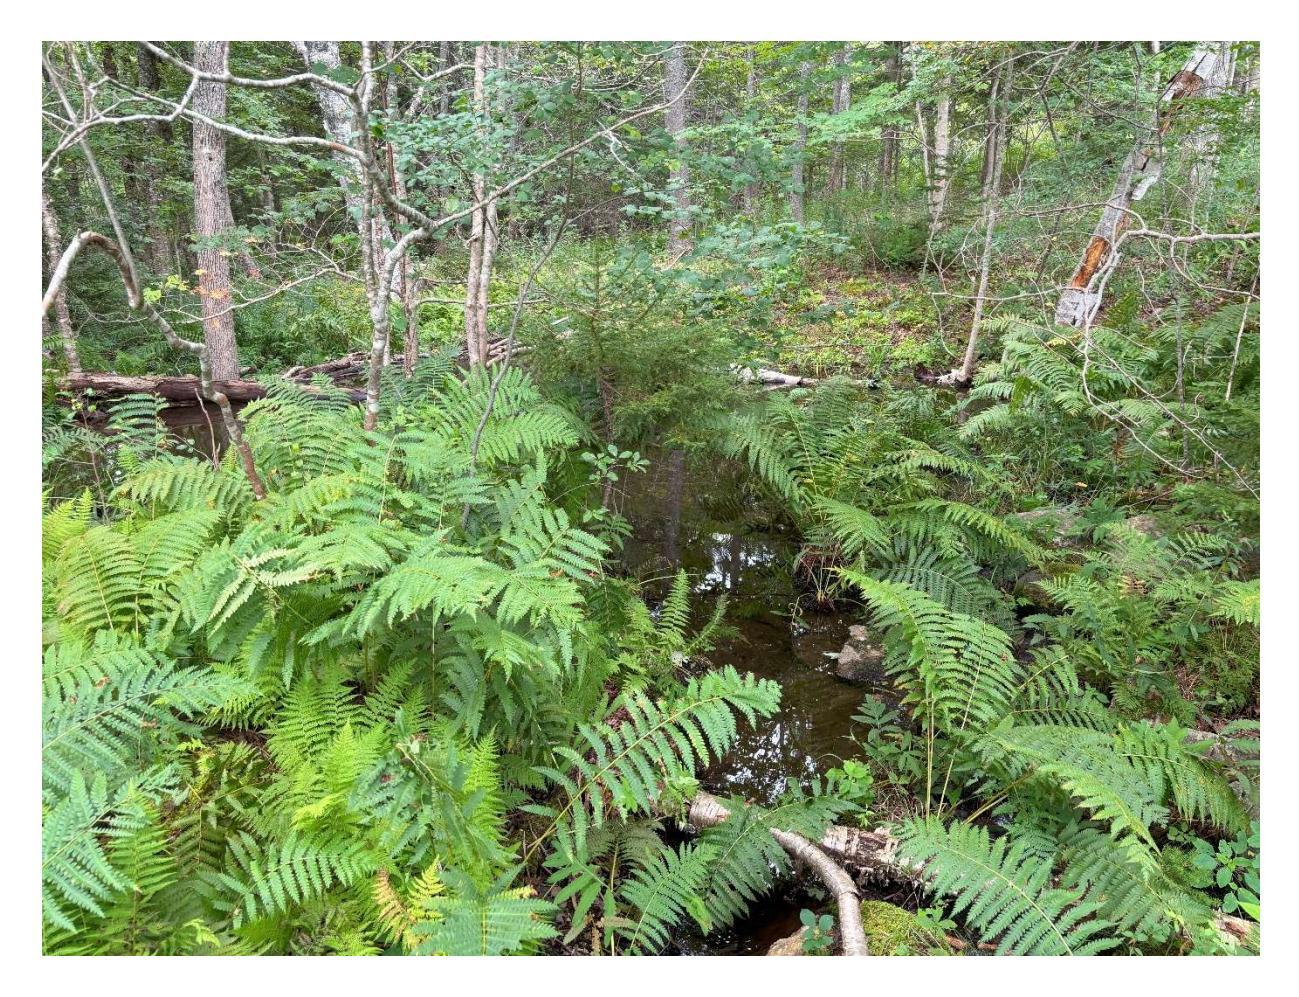
Photo 3: Standing water downstream of the left embankment. Could be the result of seepage impacts.

- Continue to periodically inspect the standing water on the downstream side of the left embankment to ensure there is no active material transport occurring.

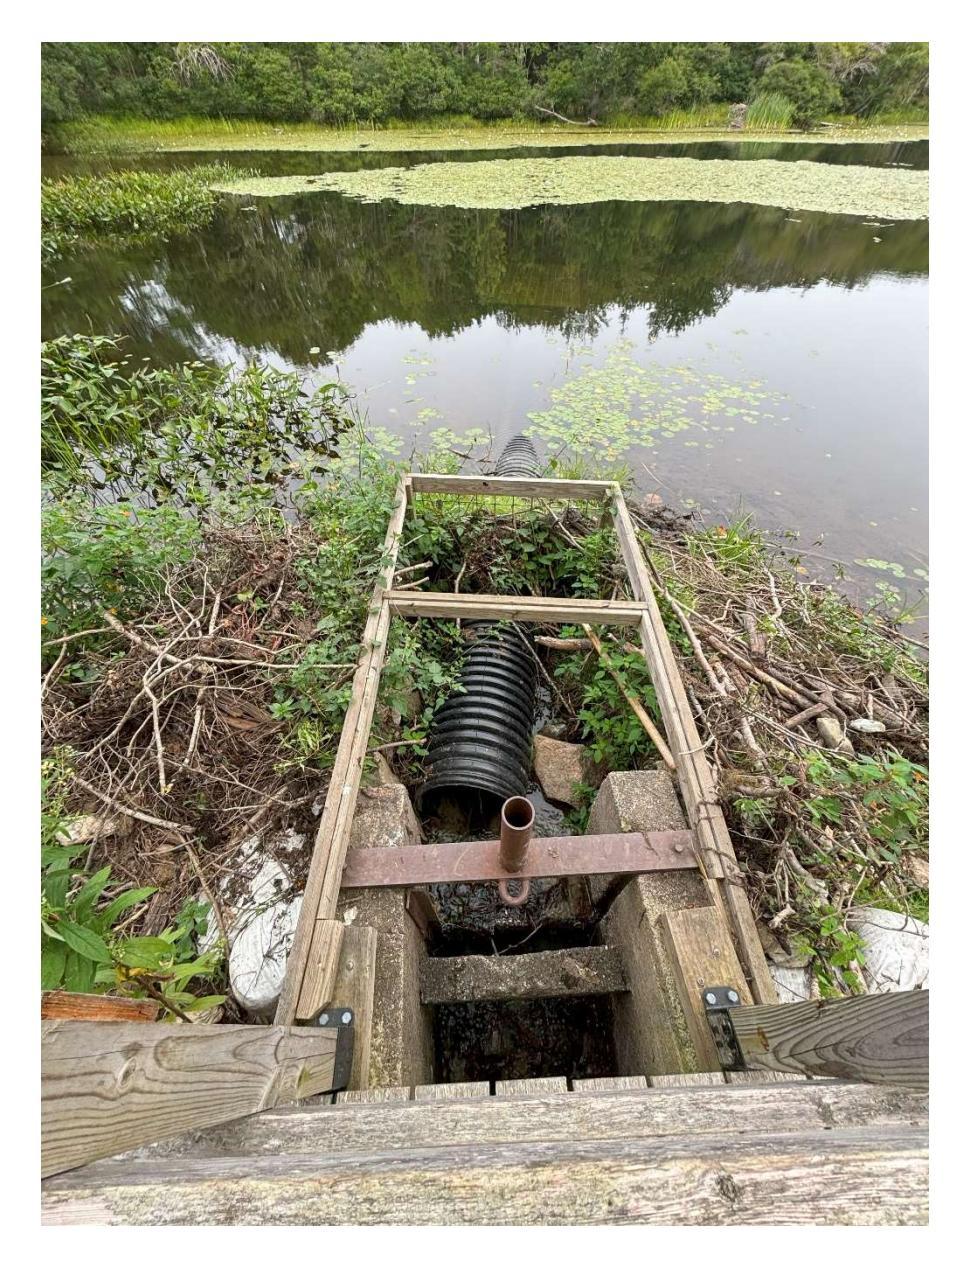
- The stoplogs on the upstream side of the spillway have been removed (Photo 4, Attachment B).
- It was noted that beavers have found an entrance to the cage around the intake/culvert and have begun to place debris inside the culvert. It is continuously being maintained to prevent further blockage from remaining inside the pipe (Photo 5, Attachment B).
- A boil was noted downstream of the spillway that may be originating from the foundation or spillway/embankment interface. Sandbags have been put in place to equalize the boil's pressure and reduce the piping potential along the seepage path (Photo 6, Attachment B).

Photo 4: The stoplogs at the intake have been removed.

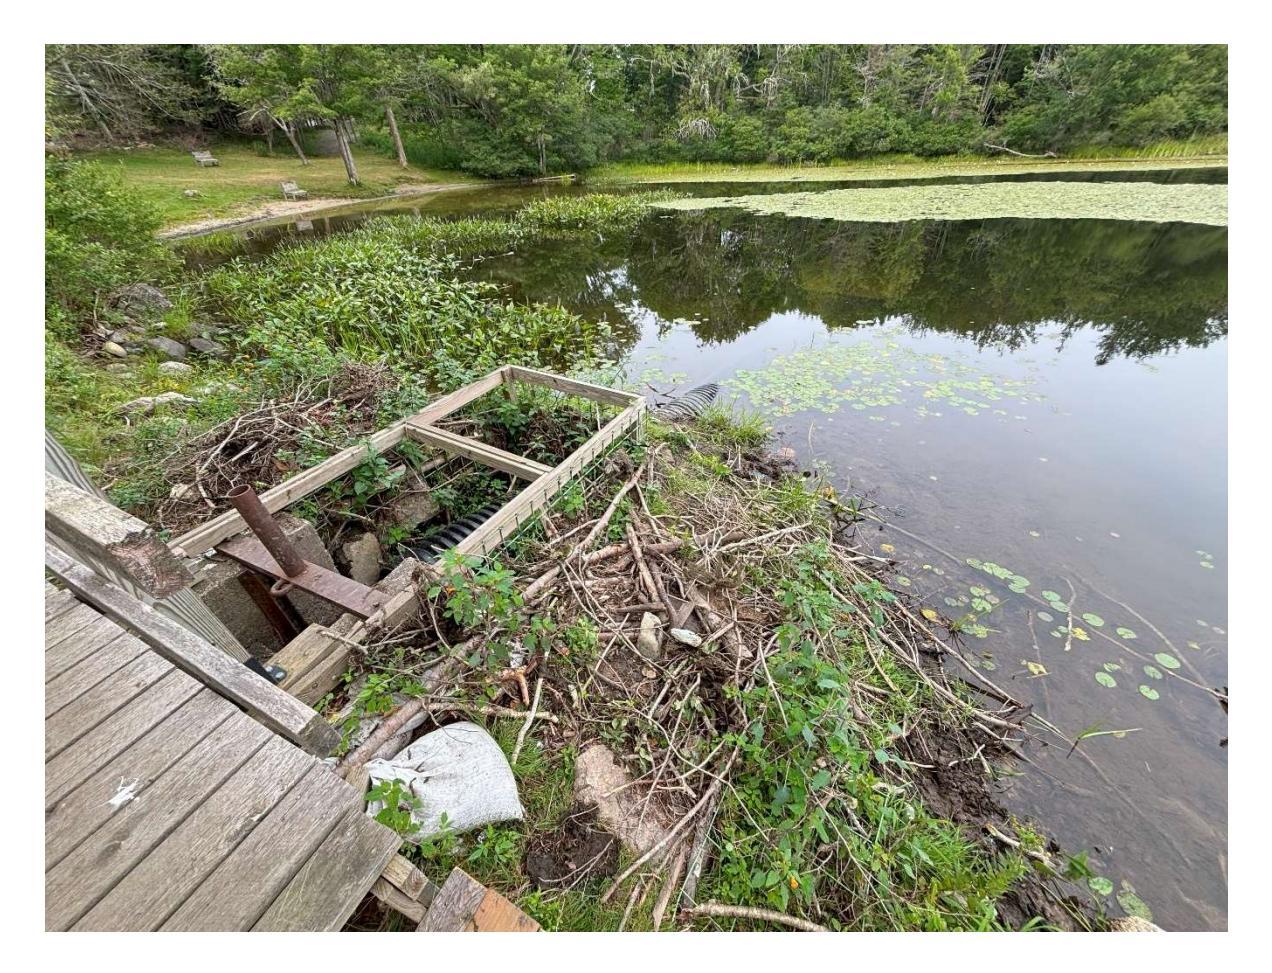
Photo 5: Prevalent beaver activity around the intake.

- Continue to monitor beaver activity to ensure that they do not continue to block the intake. If this goes unnoticed this could lead to an unexpected rise in headpond levels.

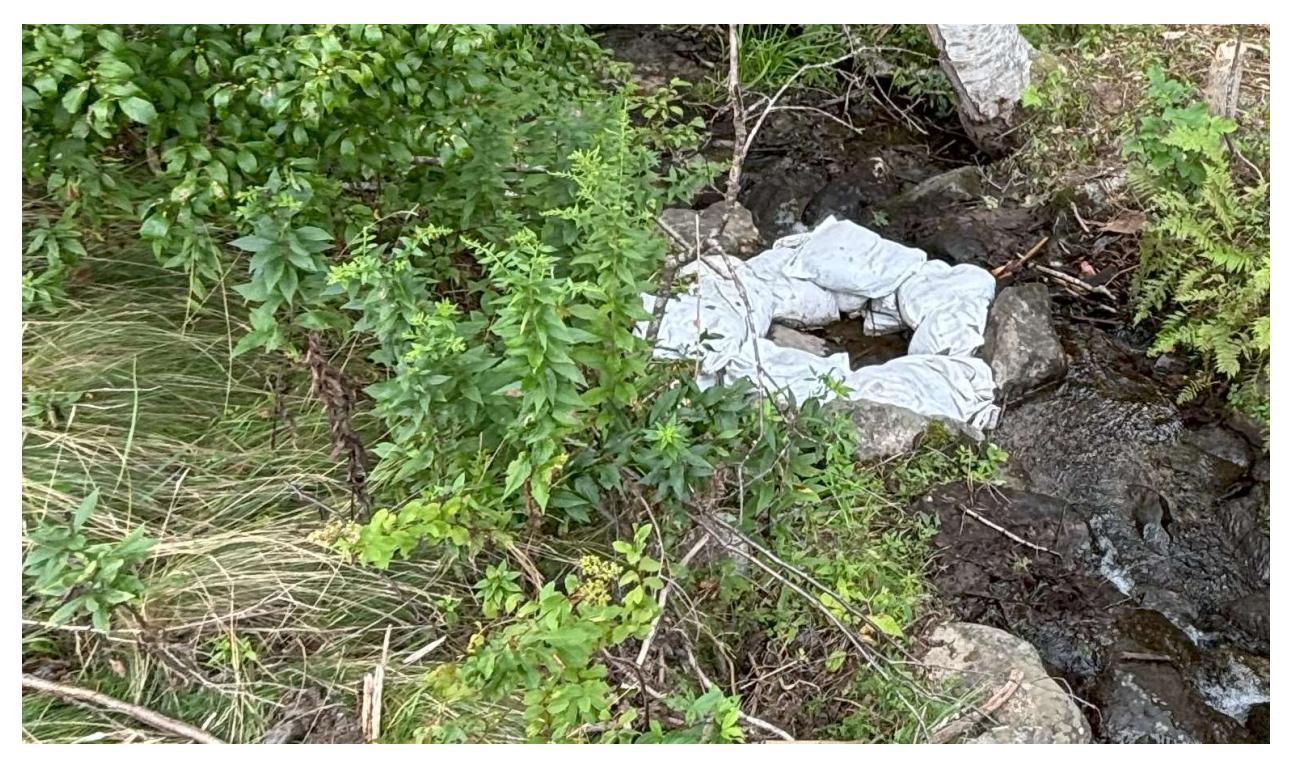
Photo 6: Downstream boil location. Mitigated with sand bags.

- Continue to apply for grant funding to obtain the means for remediate/construct a new dam.
- Continue to monitor the boil along the downstream reach of the spillway to ensure further erosion of the soil is not occurring.

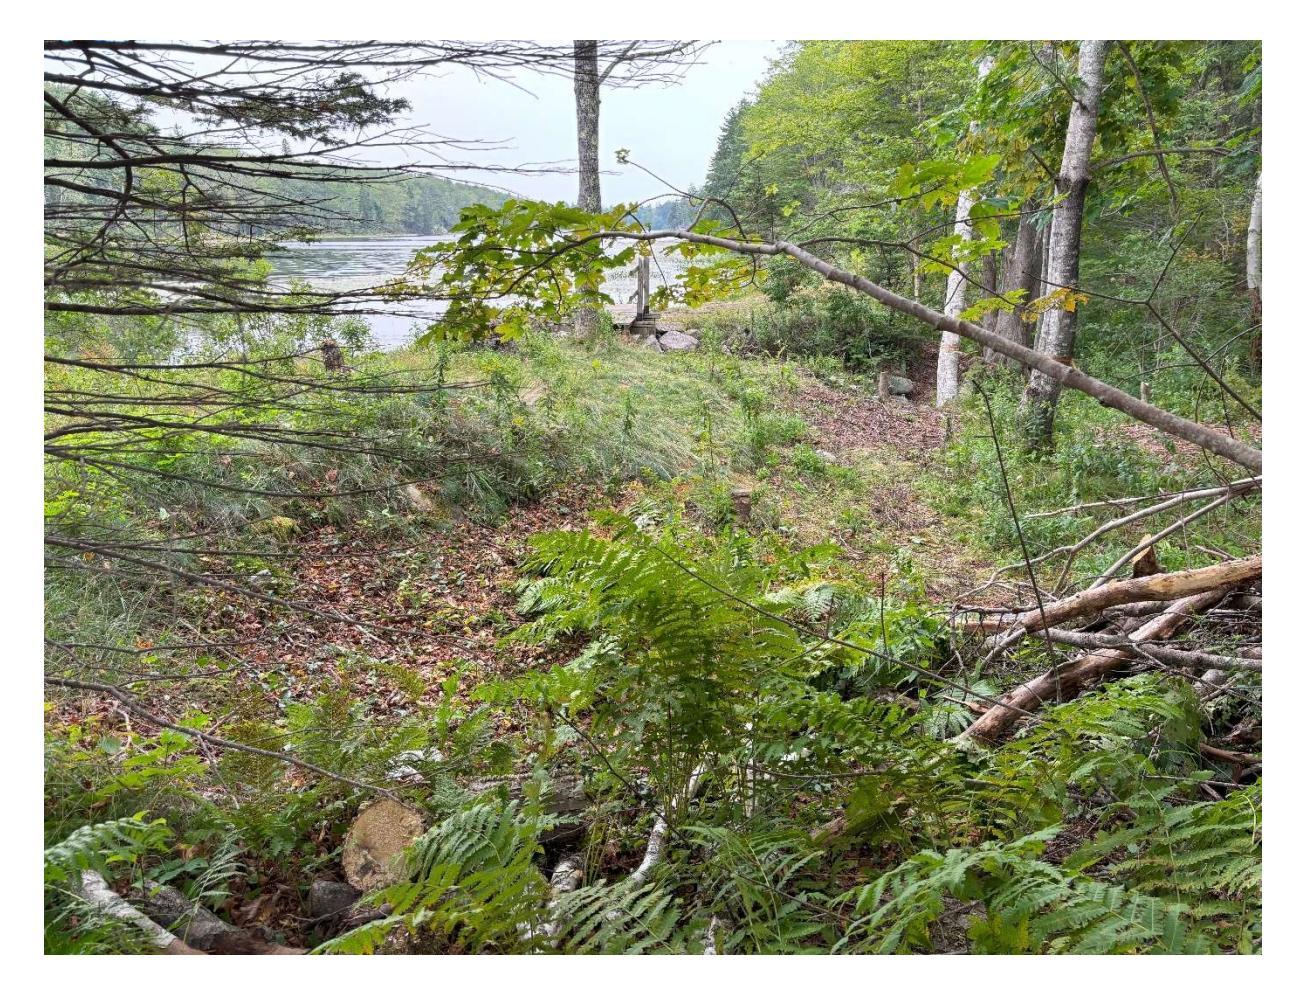
• Similar to the left embankment, tree growth was noted along the upstream and downstream slopes of the embankment along with excessive vegetation growth (Photo 7 and 8, Attachment B).

Photo 7: Vegetation and tree growth along the upstream and downstream slopes of the right embankment.

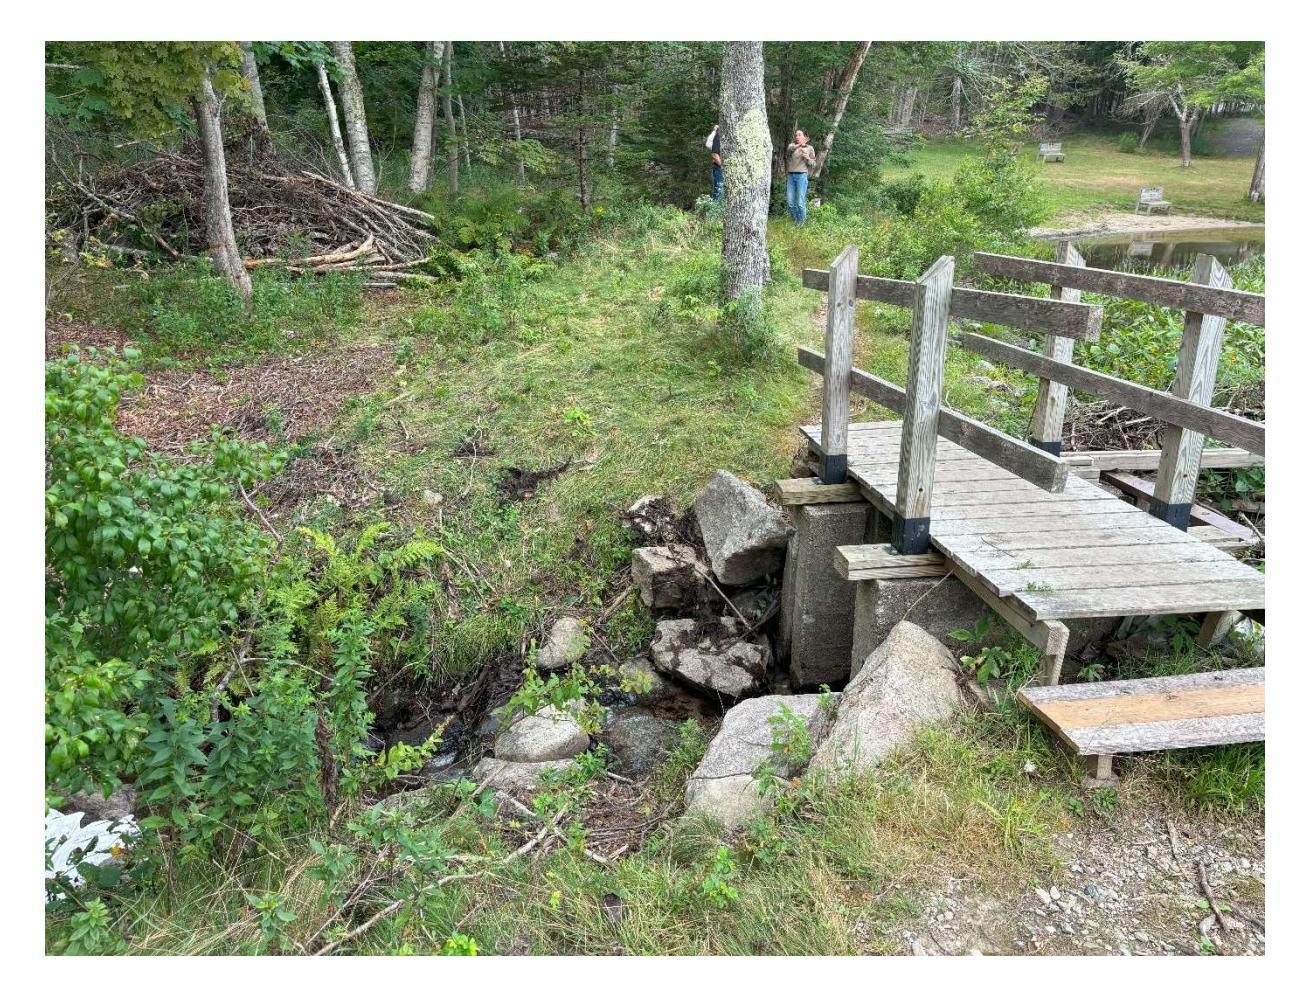
Photo 8: More large tree growth along the downstream reach of the right embankment.

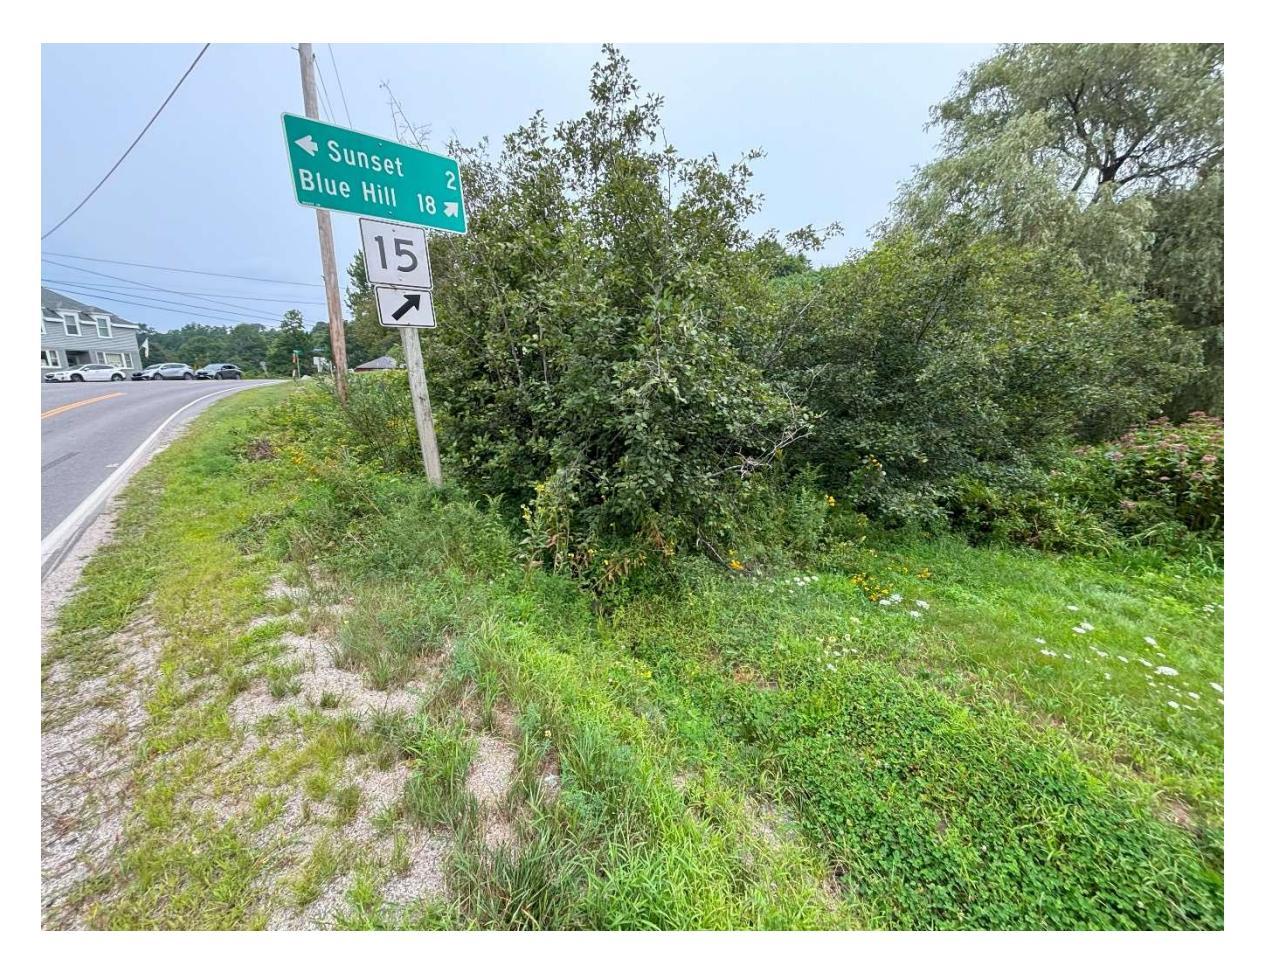
- It was brought to Kleinschmidt's attention during the inspection that the culvert at the downstream road crossing is undersized and during high flow events leads to low-lying flooding along the stream channel and backup at the road. Upon further inspections it was also noted that the stream/culvert at the road crossing is surrounded by thick brush and swamp like conditions, further reducing the capacity at the opening. Without remediation to restore capacity or replace the culvert to allow for higher capacity, the culvert restriction will continue to cause low-lying flooding of Church St. during future high flow events (Photo 9, Attachment B).
- The reservoir, located underneath the parking area immediately downstream of the culvert, is relied upon by the local fire department as a water source for fighting fires in the community (Photo 10, Attachment B).

Photo 9: Thick brush surrounding the culvert at the crossing of Church St.

- Consider replacing the culvert downstream to ensure adequate drainage during high flow events.
- Remove the thick vegetation growth surrounding the downstream culvert crossing at Church St.

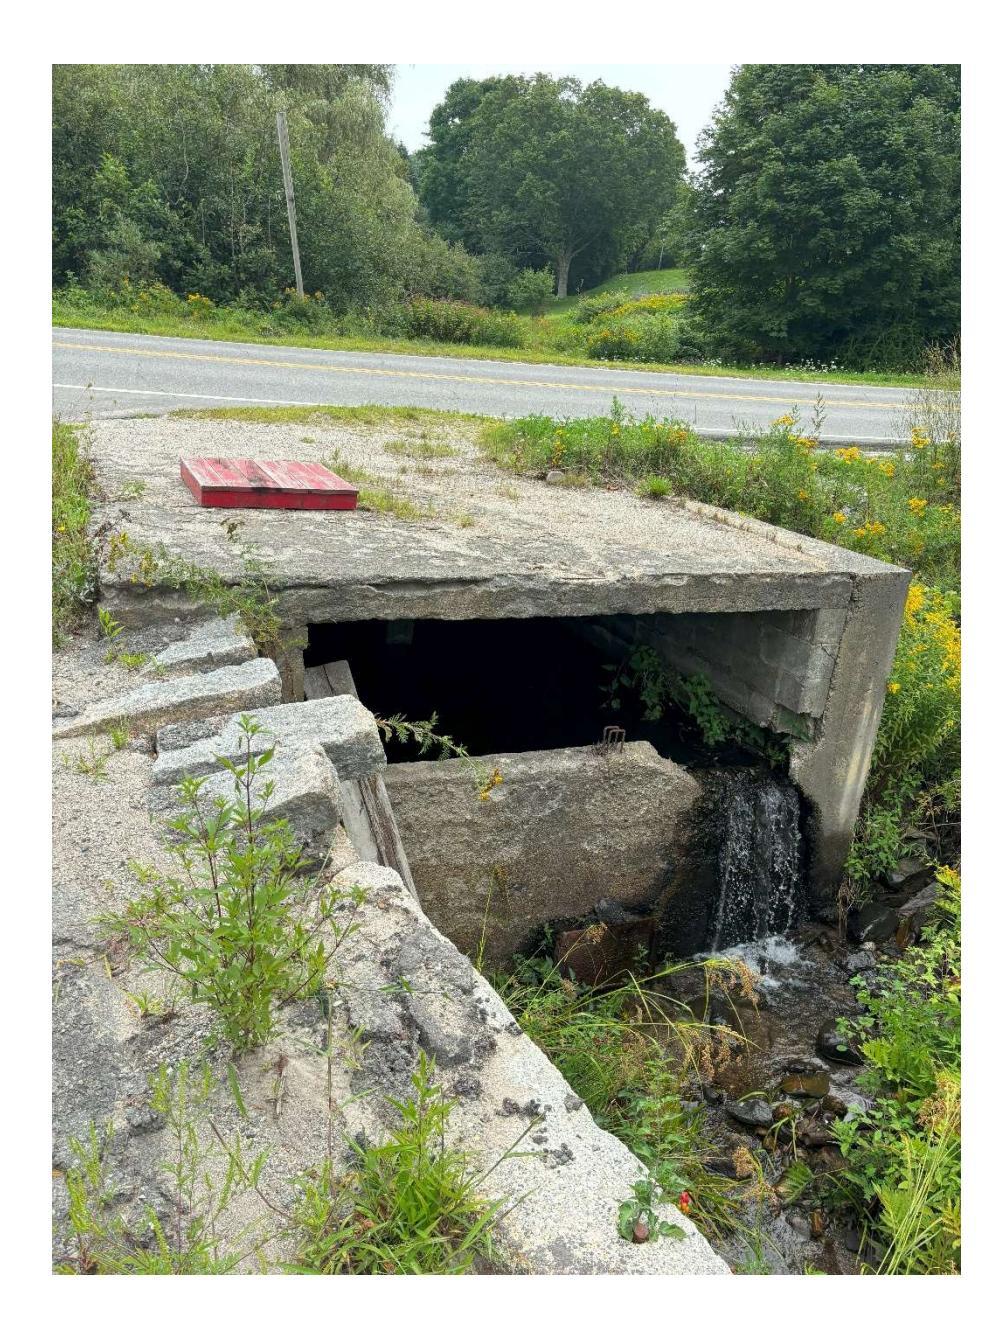
Photo 10: Reservoir located immediately downstream the culvert under the parking area along Church St. used as an emergency water supply for the Fire Dept.
