LILY POND DAM IMPROVEMENTS ASSESSMENT

DEER ISLE, MAINE

PRELIMINARY DESIGN REPORT

December 20, 2022

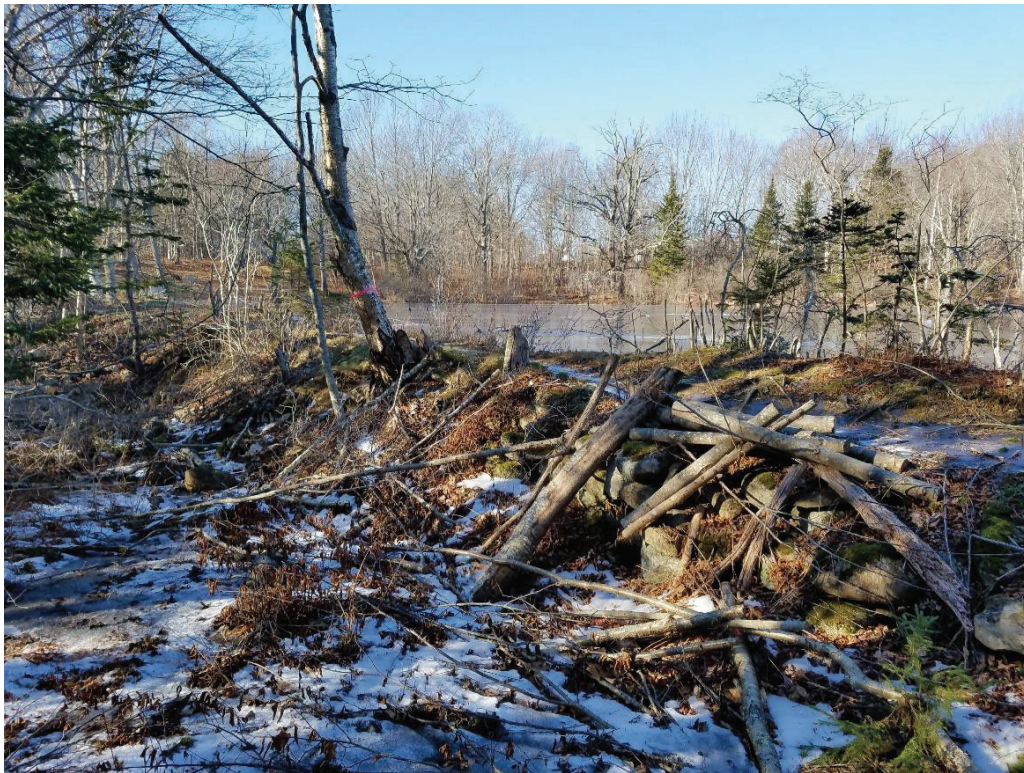
Tree removal from the dam in 2016
