LILY POND DAM IMPROVEMENTS ASSESSMENT

DEER ISLE, MAINE

PRELIMINARY DESIGN REPORT

December 20, 2022

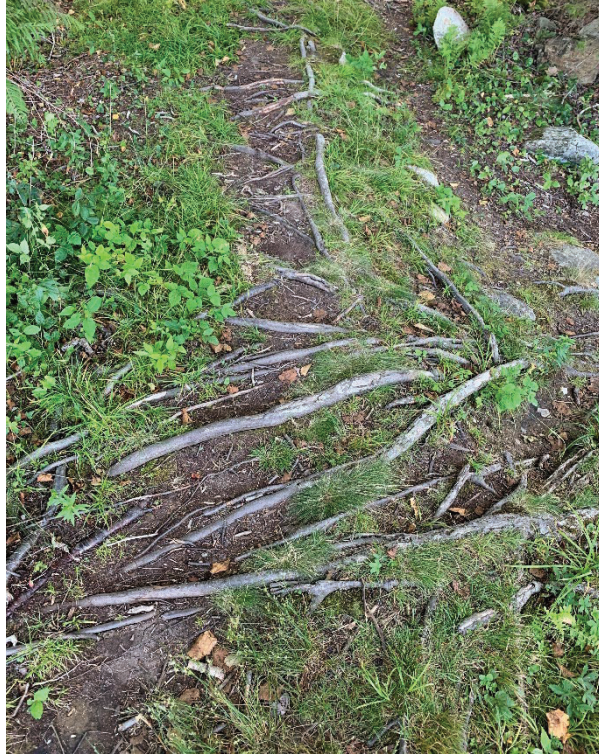
Photo 5.1: Woody root intrusion, typical along the majority of the dam

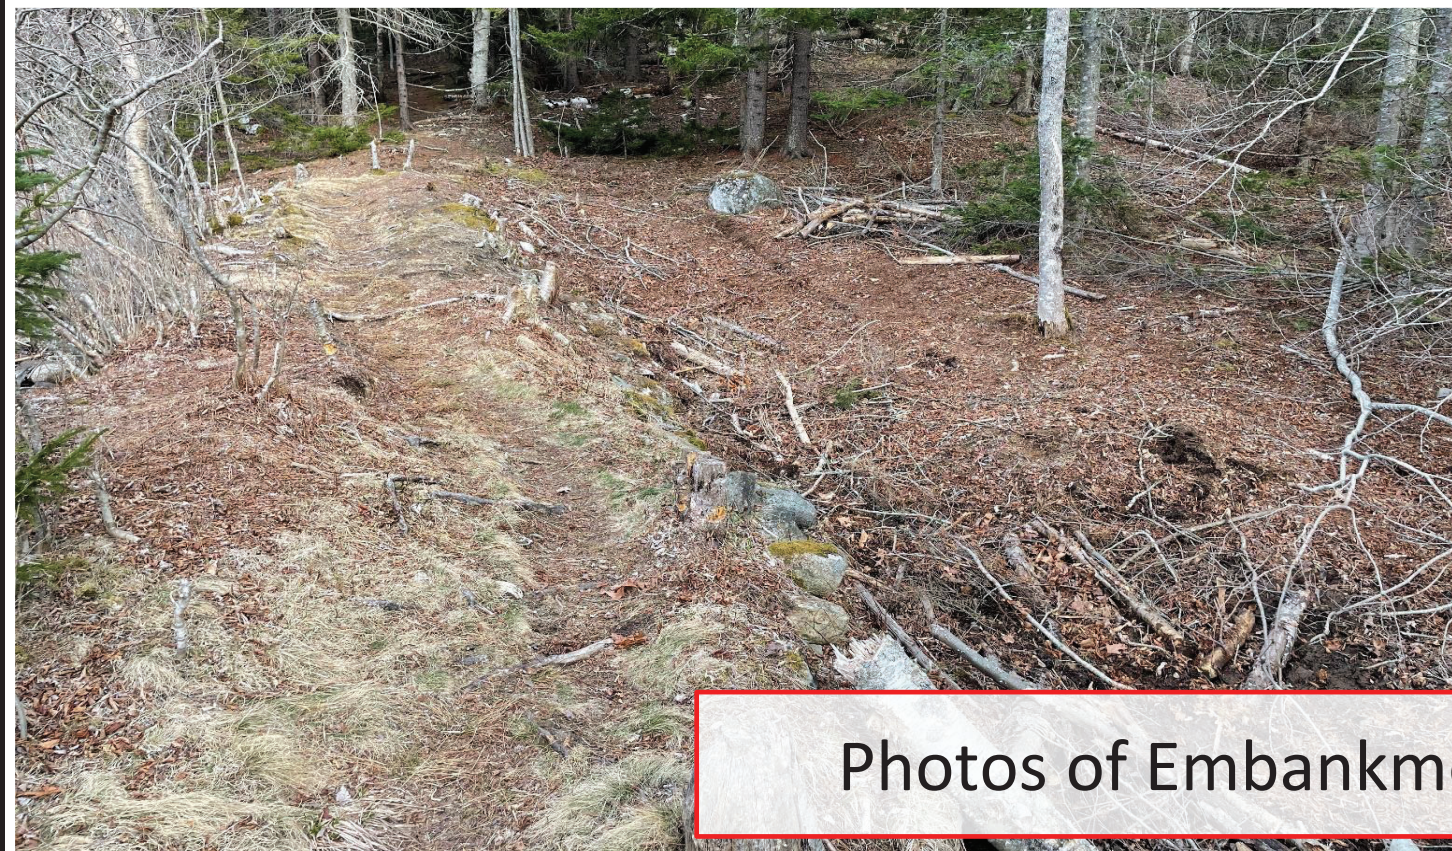
Photos of Embankment Left of Spillway

Ground surface saturated Downstream from Embankment slope

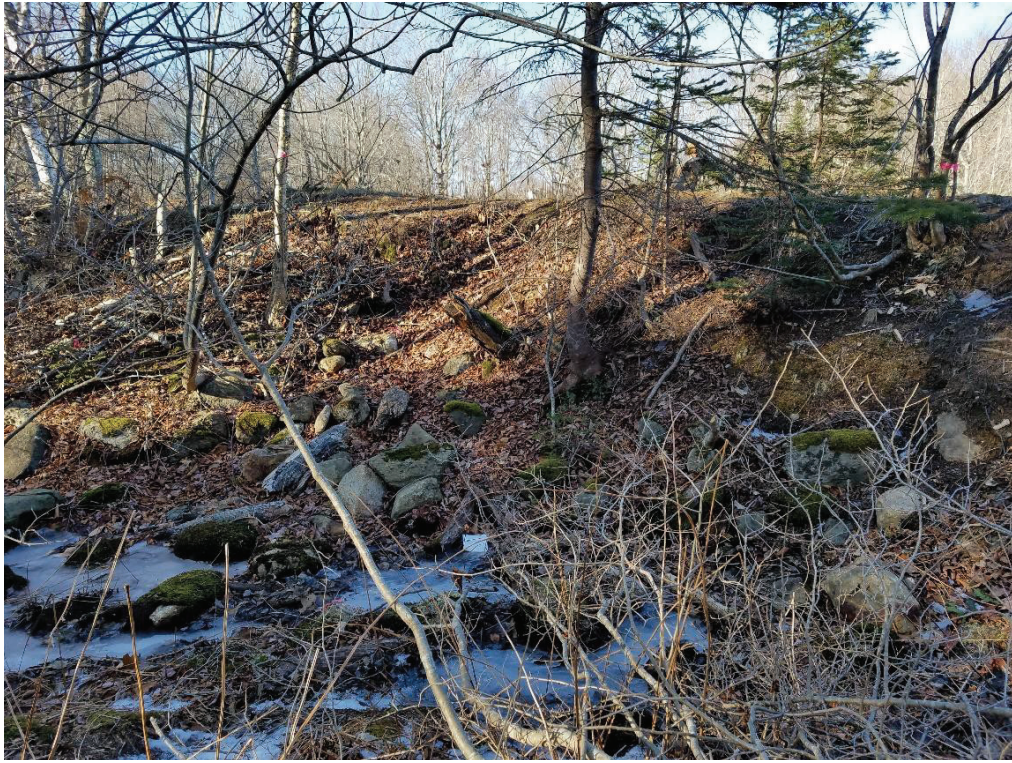
Tree removal from the dam in 2016
